SLO.DOA.002	Service Bulletin	Document-No.: SB-100-004
	Service Bulletin No.: SB-100-004	Issue: A.03
	Disconnection of all second LiFePO4 batteries	Page: 1 of 4

Disconnection of all second LiFePO4 batteries

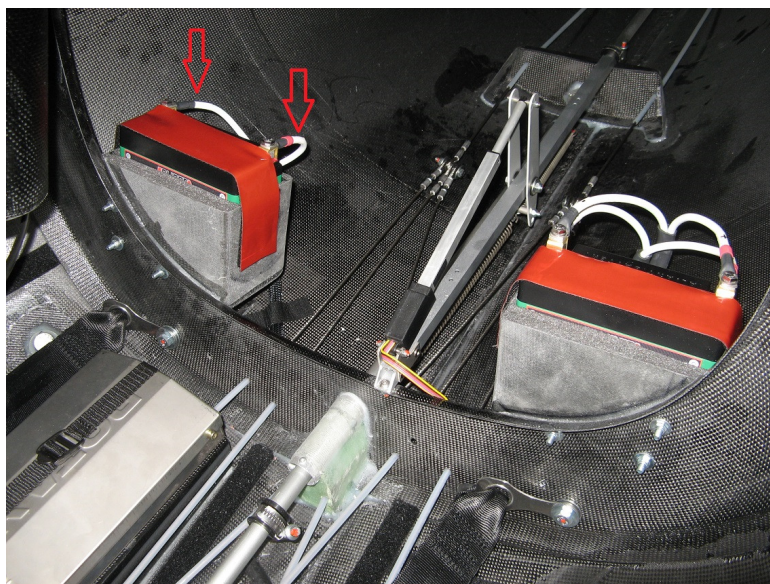
Figure 1

Concern has been raised about the use of two LiFePO4 batteries on Pipistrel aircraft. Instances of abnormal behavior and testing indicate that short circuits can occur and cause potentially dangerous current surges, if any of the batteries individual cells self-discharge to sufficiently low levels.

In those aircraft that have both batteries located in the luggage compartment, the positive and negative cables need to be disconnected from the second battery (see Figure 1). Once disconnected, they must be fastened to something with tape or plastic ties, to prevent them from shifting and/or moving around during aircraft operation. More importantly, the cable terminals, as well as the battery terminals, must be thoroughly insulated/protected to prevent them from touching components/installations nearby. After the cable is disconnected, the second battery can either be left where it is or removed. Only the later requires redetermining the aircraft's weight and balance.
