<h1>Service Bulletin</h1>		Document Number
			<b>SB-100-004 LSA</b>
			Issue: A.03
<b>Pipistrel LSA s.r.l.</b> Via Aquileia 75 34170 Gorizia, Italy, EU <a href="http://www.pipistrel.eu">www.pipistrel.eu</a> Phone: 0481 522000	<b>Disconnection of all second LiFePO4 batteries</b>		Supersedes Doc. Number
			A.02
			Page 1 of 6
Aircraft make	Aircraft model	Affected serial numbers	
<b>PIPISTREL</b>	<b>Sinus, Virus, Virus SW and ALPHA trainer</b>	<b>See cover page</b>	
Date of issue	Date of effect	Date of required corrective action	
27 June 2017	27 June 2017	Before next flight

## Disconnection of all second LiFePO4 batteries

- Category:** MANDATORY
- Subject:** Disconnection of all second LiFePO4 batteries
- Affected Aircraft s.n.:** All Sinus, Virus, Virus SW and ALPHA trainer aircraft that have two LiFePO4 batteries installed
- Time of Compliance:** Immediate.
- Reason:** To prevent any chance of a short circuit occurring and causing potentially dangerous current surges
- Actions:** Disconnect the second LiFePO4 battery and, if desired, remove it
- Documents:** N/A
- Required Material:** N/A
- Mass and Balance:** Must be redetermined only if the second battery is removed from the air

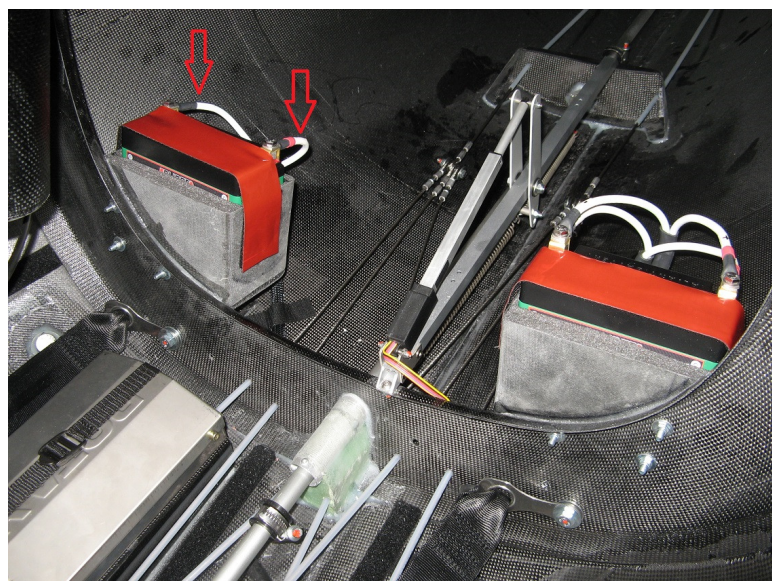
**Figure 1**

Concern has been raised about the use of two LiFePO4 batteries on Pipistrel aircraft. Instances of abnormal behavior and testing indicate that short circuits can occur and cause potentially dangerous current surges, if any of the batteries individual cells self-discharge to sufficiently low levels.

In those aircraft that have both batteries located in the luggage compartment, the positive and negative cables need to be disconnected from the second battery (see Figure 1). Once disconnected, they must be fastened to something with tape or plastic ties, to prevent them from shifting and/or moving around during aircraft operation. More importantly, the cable terminals, as well as the battery terminals, must be thoroughly insulated/protected to prevent them from touching components/installations nearby. After the cable is disconnected, the second battery can either be left where it is or removed. Only the later requires redetermining the aircraft's weight and balance.
