DOA No.: EASA.21J.524	<b>Service Bulletin</b>	Document-No.: <b>SB-124-002</b>
	<b>Service Bulletin No.: SB-124-002</b>	Issue: <b>A.00</b>
	<b>Preventative Inspection of Exhaust System</b>	Page: <b>1 of 5</b>

## Virus SW 100 iS Preventative Inspection of Exhaust System

**Subject:** Preventative Inspection of Exhaust System

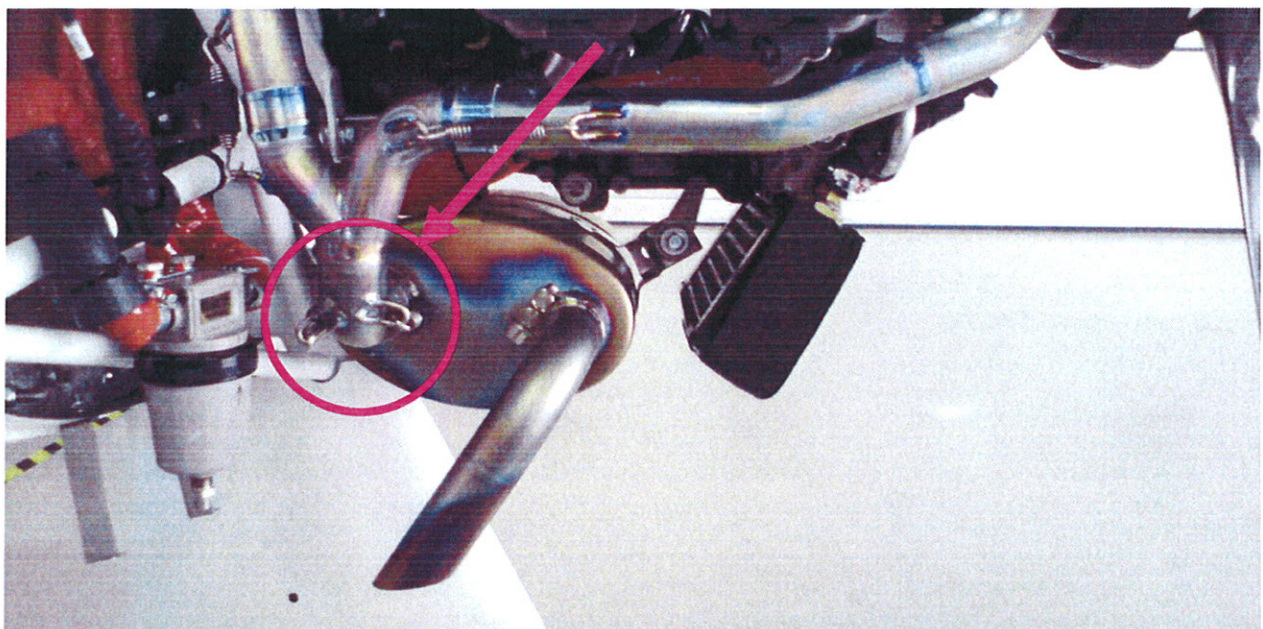
With upgrade to Rotax 912 iS Sport configuration the operating performance of the engine is increased, causing higher load on the exhaust system. As a consequence it may occur that the header tube spring attachments near the muffler cause tube deformation. Deformation of the tube is permissible as long as there is no cracking of the area.

Inspect area shown on the figure (only one side of muffler shown, inspect opposite side as well!):

Observe that no cracks are present.

**Should cracks appear, contact Pipistrel's representative for further support.**
