PIPISTREL SLO.DOA.002	<h1>Service Bulletin</h1>	Document Number
		SB-131-008
Pipistrel d.o.o. Ajdovščina Goriška cesta 50a SI-5270 Ajdovščina, Slovenia www.pipistrel.eu Phone: +38653663873	Replacement of engine mast attachment assembly	Issue: A.01
		Supersedes Doc. Number
		N/A
		Page 1 of 3
Aircraft make	Aircraft model	Affected serial numbers
PIPISTREL	Taurus	See cover page
Date of issue	Date of effect	Date of required corrective action
26 January 2016	26 January 2016	Before next flight

Taurus – Replacement of engine mast attachment assembly

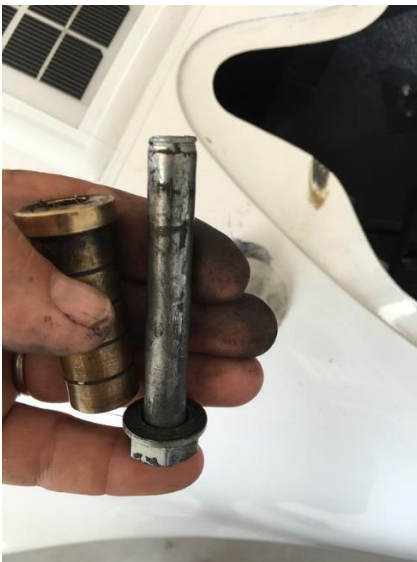
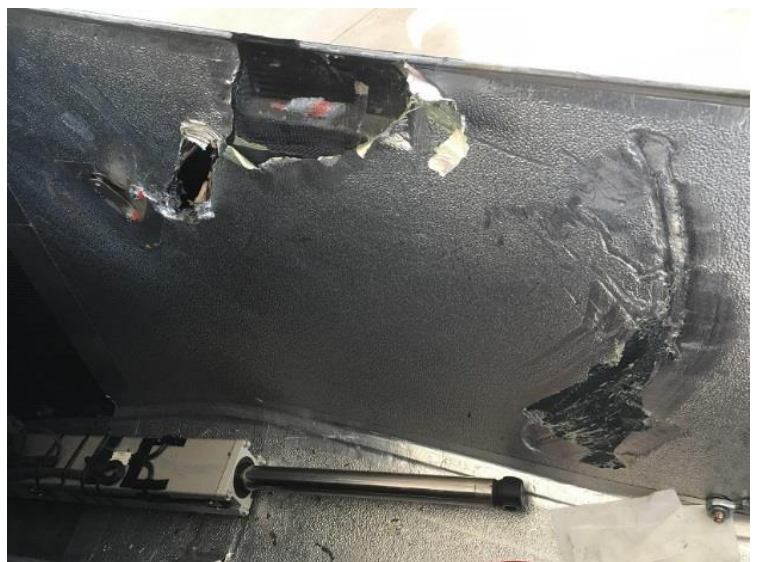
An incident occurred resulting in permanent damage to the bolt which acts as an axle between the propulsion unit swing-arm and the Taurus fuselage (P/N 1350038, position 21 on page 63 of IPC Taurus Rev 2 – March 2013), forcing the pilot to carry out an emergency landing. It was determined that the bolt seized due to lack of lubrication.

To prevent such incidents from occurring certain swing-arm/fuselage pivot joint components need to be replaced with lubrication-enabled ones as per instructions in PI-13A-71-00-010_A00. With the new parts installed, lubricate bushing every 10 hours of engine operation. Kit P/N 1350230 has all of the material and parts needed to carry out the replacement and can be ordered by sending a request to spareparts@pipistrel.si
