<h1>Service Bulletin</h1>		Document Number
			<b>SB-132-008 LSA</b>
			Issue: A.01
<b>Pipistrel LSA s.r.l.</b> Via Aquileia 75 34170 Gorizia, Italy, EU <a href="http://www.pipistrel.eu">www.pipistrel.eu</a> Phone: 0481 522000	<b>Replacement of engine mast attachment assembly</b>		Supersedes Doc. Number
			N/A
			Page 1 of 3
Aircraft make	Aircraft model	Affected serial numbers	
<b>PIPISTREL</b>	<b>Taurus</b>	<b>See cover page</b>	
Date of issue	Date of effect	Date of required corrective action	
26 January 2016	26 January 2016	Before next flight

## Taurus – Replacement of engine mast attachment assembly

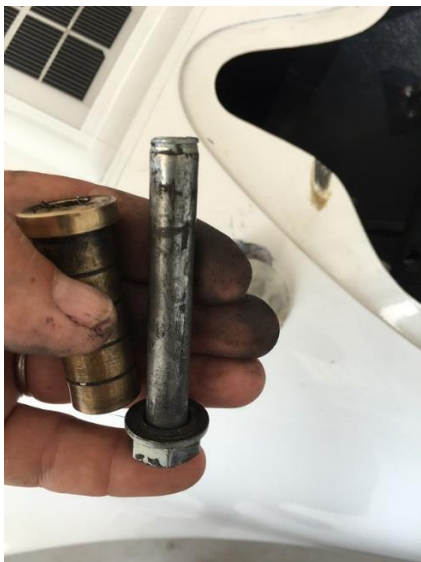
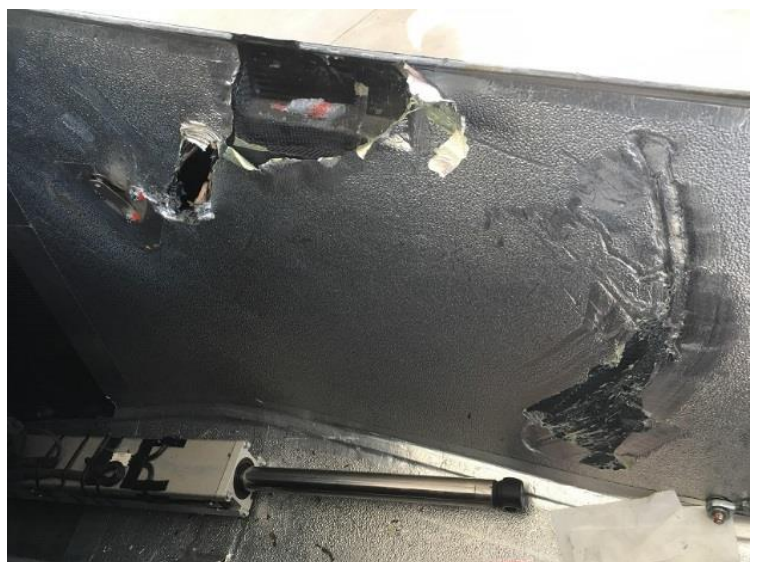
An incident occurred resulting in permanent damage to the bolt which acts as an axle between the propulsion unit swing-arm and the Taurus fuselage (P/N 1350038, position 21 on page 63 of IPC Taurus Rev 2 – March 2013), forcing the pilot to carry out an emergency landing. It was determined that the bolt seized due to lack of lubrication.

To prevent such incidents from occurring certain swing-arm/fuselage pivot joint components need to be replaced with lubrication-enabled ones as per instructions in PI-13A-71-00-010\_A00. With the new parts installed, lubricate bushing every 10 hours of engine operation. Kit P/N 1350230 has all of the material and parts needed to carry out the replacement and can be ordered by sending a request to [spareparts@pipistrel.si](mailto:spareparts@pipistrel.si)
