PIPISTREL SLO.DOA.002	<h1>Service Bulletin</h1>	Document Number
		SB-133-008
		Issue: A.01
Pipistrel d.o.o. Ajdovščina Goriška cesta 50a SI-5270 Ajdovščina, Slovenia www.pipistrel.eu Phone: +38653663873	Replacement of motor mast attachment assembly	Supersedes Doc. Number
		N/A
		Page 1 of 3
Aircraft make	Aircraft model	Affected serial numbers
PIPISTREL	Taurus Electro	See cover page
Date of issue	Date of effect	Date of required corrective action
26 January 2016	26 January 2016	Before next flight

Taurus – Replacement of motor mast attachment assembly

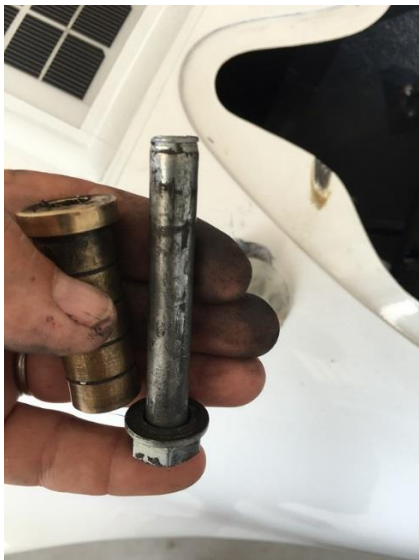
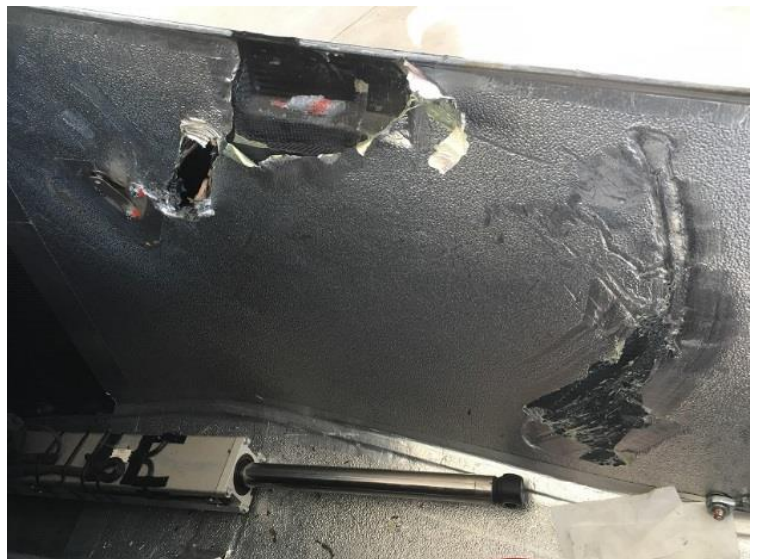
An incident occurred on a Rotax powered Taurus resulting in permanent damage to the bolt which acts as an axle between the propulsion unit swing-arm and the Taurus fuselage (P/N 1350038, position 21 on page 63 of IPC Taurus Rev 2 – March 2013), forcing the pilot to carry out an emergency landing. It was determined that the bolt seized due to lack of lubrication.

To prevent such incidents from occurring certain swing-arm/fuselage pivot joint components need to be replaced with lubrication-enabled ones as per instructions in PI-13A-71-00-010_A00. With the new parts installed, lubricate bushing every 10 hours of motor operation. Kit P/N 1350230 has all of the material and parts needed to carry out the replacement and can be ordered by sending a request to spareparts@pipistrel.si
