## **SB-T-01**

### **SERVICE BULLETIN No. 01**

# **Brake pad wear and condition for replacement**

### **Applies to all Taurus aircraft.**

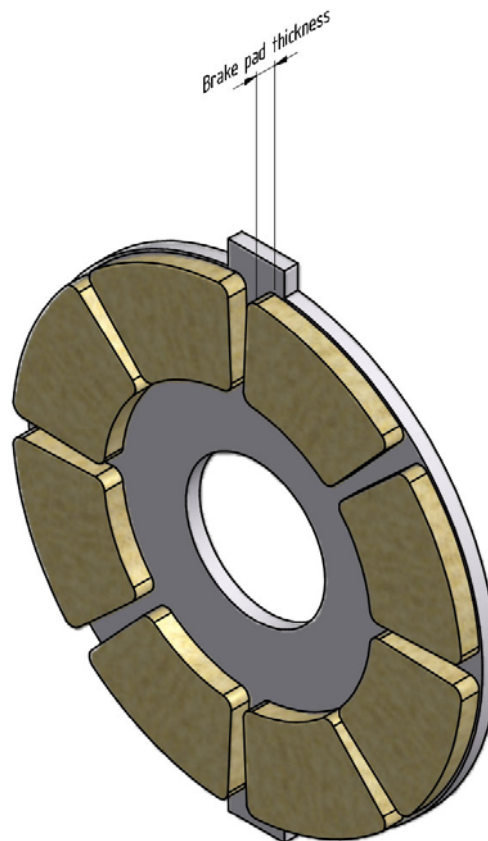
Check the thickness of the brake pads in both main wheels of the undercarriage. Brake pad thickness is critical for adequate braking action and integrity of the system.

The minimum recommended brake pad thickness for normal brake operation is 2 mm. The absolute minimum brake pad thickness is 1.5 mm. Should the actual brake pad thickness be less, replace the brake-pad with a new part immediately.
