SB-T-04

SERVICE BULLETIN No. 04 to all distributors, owners

Checking of Rudder Cable Fitting

**Aircraft affected: Taurus up to serial number
070 T 503** ||

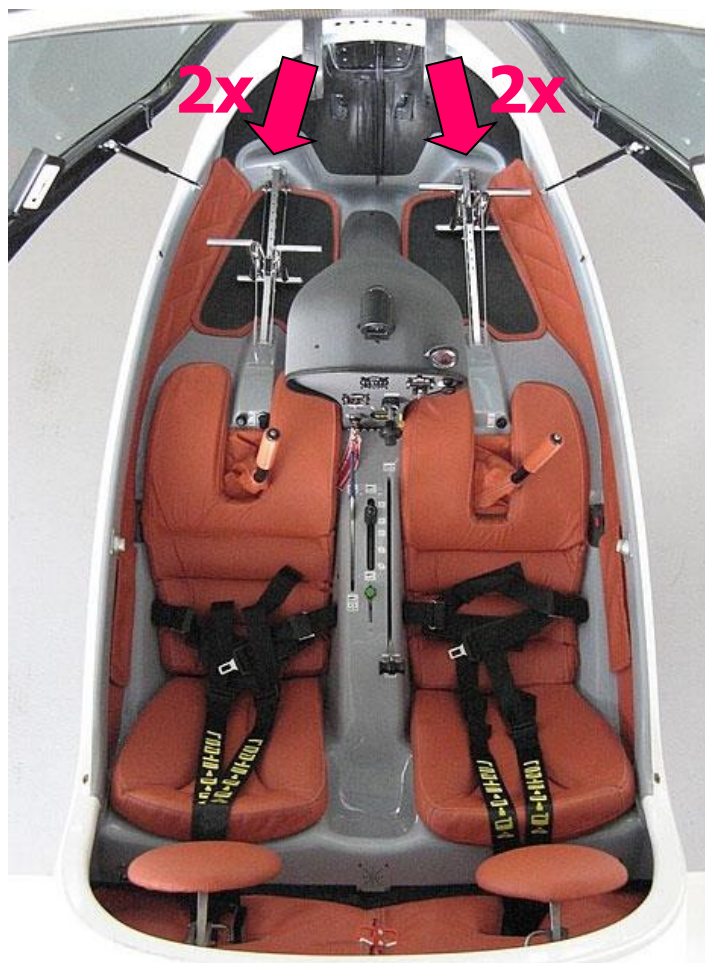
Figure 1

Before next flight, you are required to check that the distance D shown on Figure 2 measures a maximum of 17 mm. Check all 4 cables, two on the left side, two on the right side (Figure 1) of the cabin. If you discover that D is larger than 17 mm on any of the cables, please contact leon.b@pipistrel.si for further instructions.

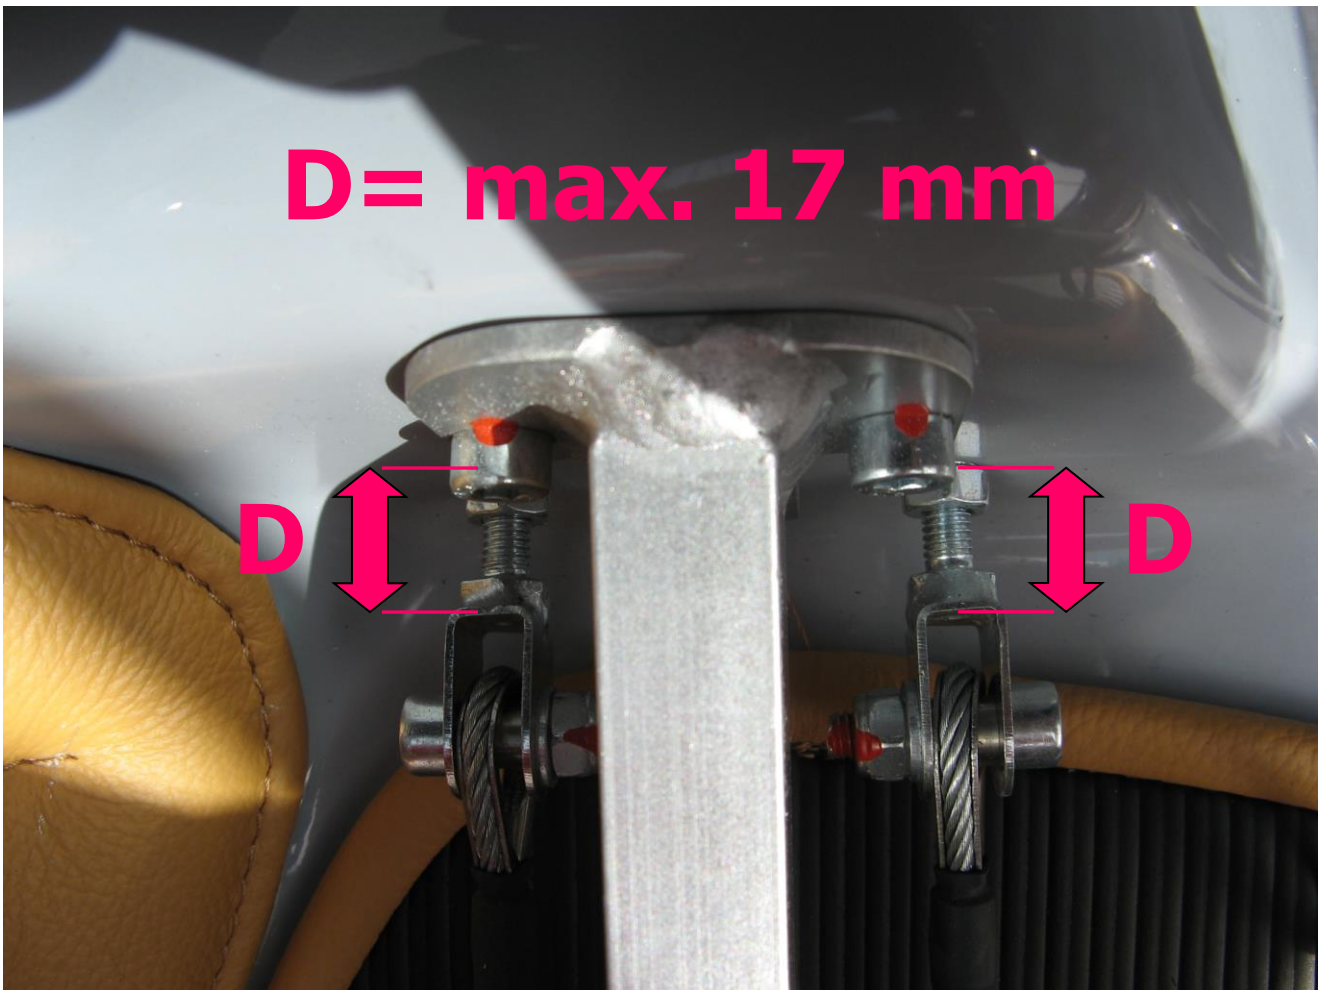
Figure 2

During service check-ups of customers' Taurus aircraft, which have returned to the factory for larger service works, we have discovered that settings of the rudder cable system were in some cases different than those originally set by the factory. This would not be alarming if certain settings, which were done by the owners, had not been outside safe tolerances. If the rudder cable fitting is not proper, the cable can detach completely and rudder control is lost.

WARNING! Operating the aircraft without checking for adequate rudder cable fitting or with the discussed measurement D larger than 17 mm can lead to failure of rudder/directional control and hence to severe deterioration of flight safety and hazardous situations, including such resulting in aircraft damage, serious injury and loss of life.

NOTE: Above serial number 070 T 503, Max measurement of D is 25 mm
