SB-T-04

SERVICE BULLETIN No. 04

Checking of Rudder Cable Fitting

Aircraft affected: all Taurus aircraft

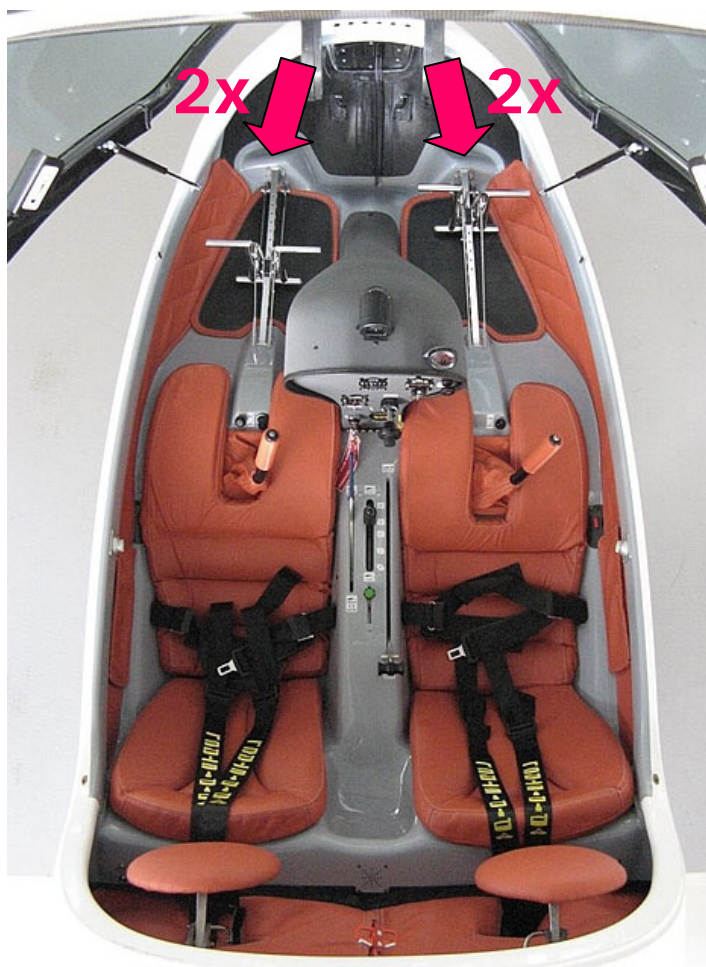
Figure 1

Before next flight, you are required to check that the distance D shown on Figure 2 measures a maximum of 17 mm. Check all 4 cables, two on the left side, two on the right side (Figure 1) of the cabin. If you discover that D is larger than 17 mm on any of the cables, please contact leon.b@pipistrel.si for further instructions.

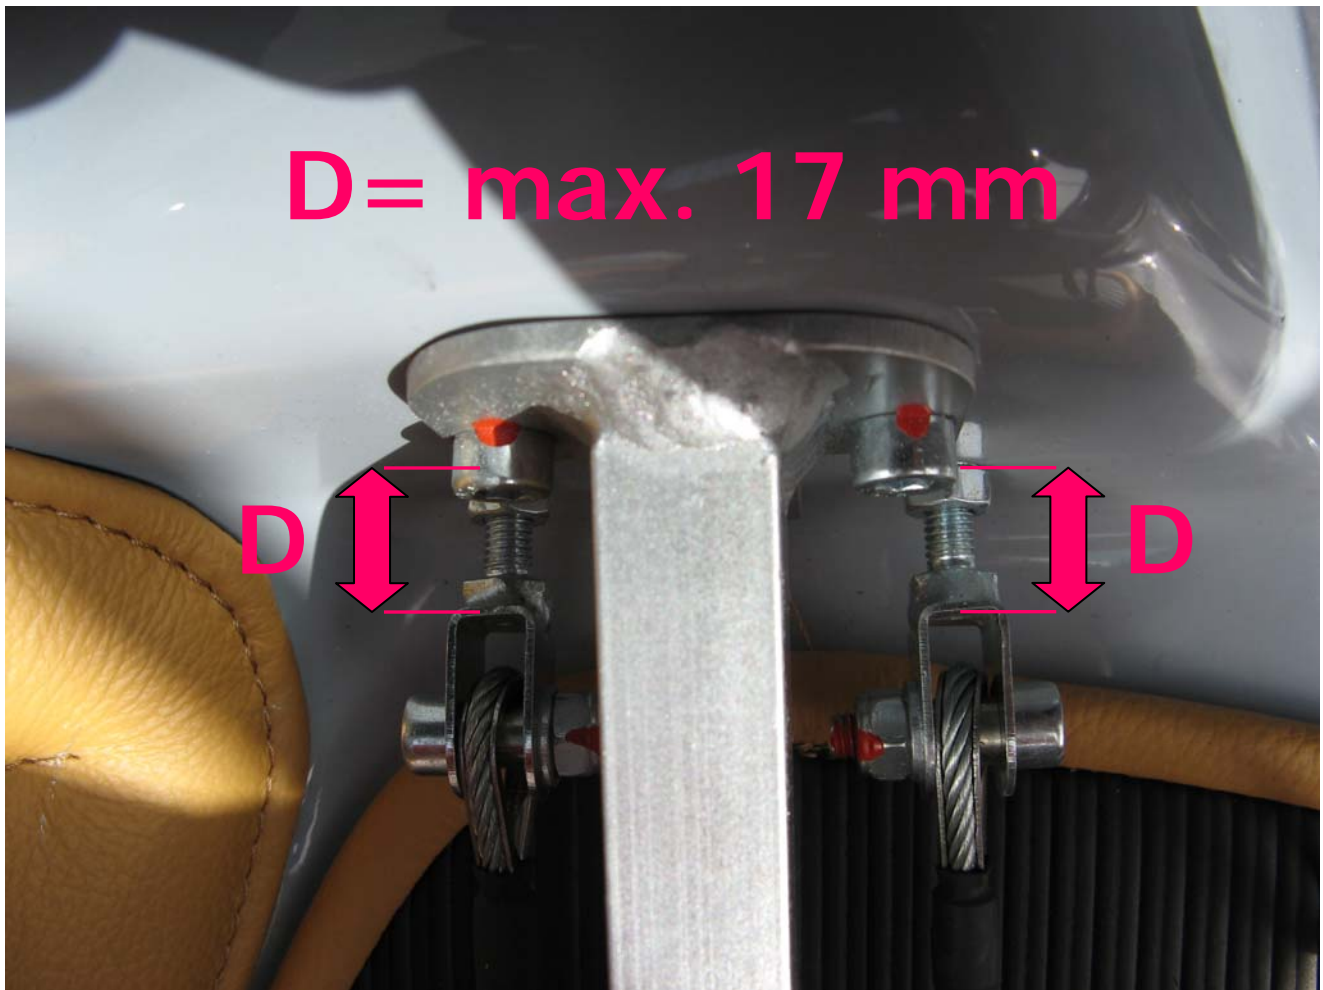
Figure 2

During service check-ups of customers' Taurus aircraft, which have returned to the factory for larger service works, we have discovered that settings of the rudder cable system were in some cases different than those originally set by the factory. This would not be alarming if certain settings, which were done by the owners, had not been outside safe tolerances. If the rudder cable fitting is not proper, the cable can detach completely and rudder control is lost.

WARNING! Operating the aircraft without checking for adequate rudder cable fitting or with the discussed measurement D larger than 17 mm can lead to failure of rudder/directional control and hence to severe deterioration of flight safety and hazardous situations, including such resulting in aircraft damage, serious injury and loss of life.
