SB-T-06

SERVICE BULLETIN No. 06

Replacement of master switch fixation screw

Applies to all Taurus 503 aircraft up to serial number 083 T 503

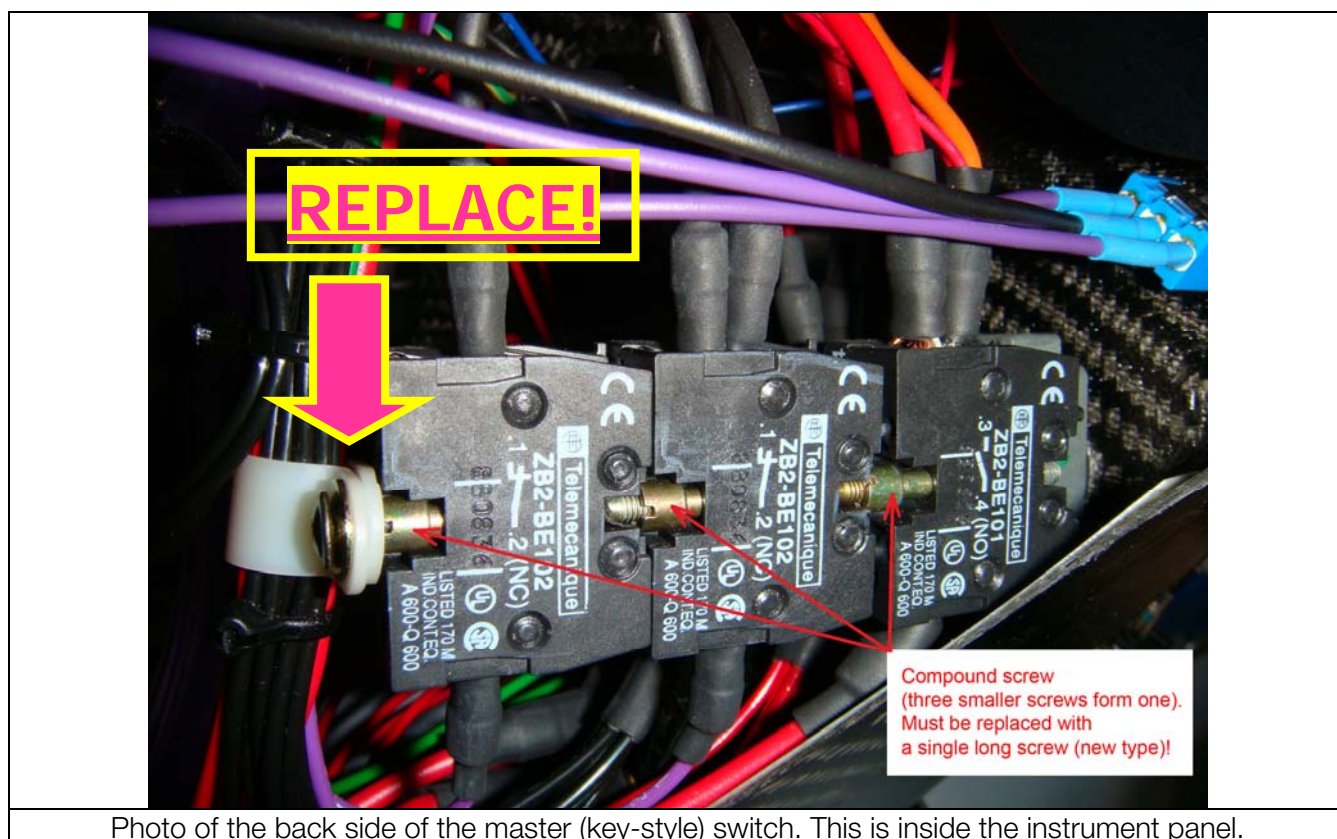
While carrying-out our ongoing endurance factory testing of the Taurus, a potential risk of the master switch fixation screw failure due to a combination of factors has been discovered.

The master switch is the key-style switch on the instrument panel. Inside the instrument panel there are three elements, which make the master switch a functional unit. They are held together with a compound 3-part screw, made of three short screws attached end-to-end. In certain cases, it is possible that one or more of these short individual screws fail, causing the master switch to fail as a consequence.

Owners/operators are required to replace the compound 3-part screw (see image above) with a single, longer screw (new type).
