**CIRCULAR LETTER No. 08**  
**SERVICE BULLETIN No. 04**  
to all distributors

**Checking or replacing gascolator's retaining  
spring on Sinus ultralight motorglider,  
Virus 912**

**Aircraft affected: SN.86 to SN.111**

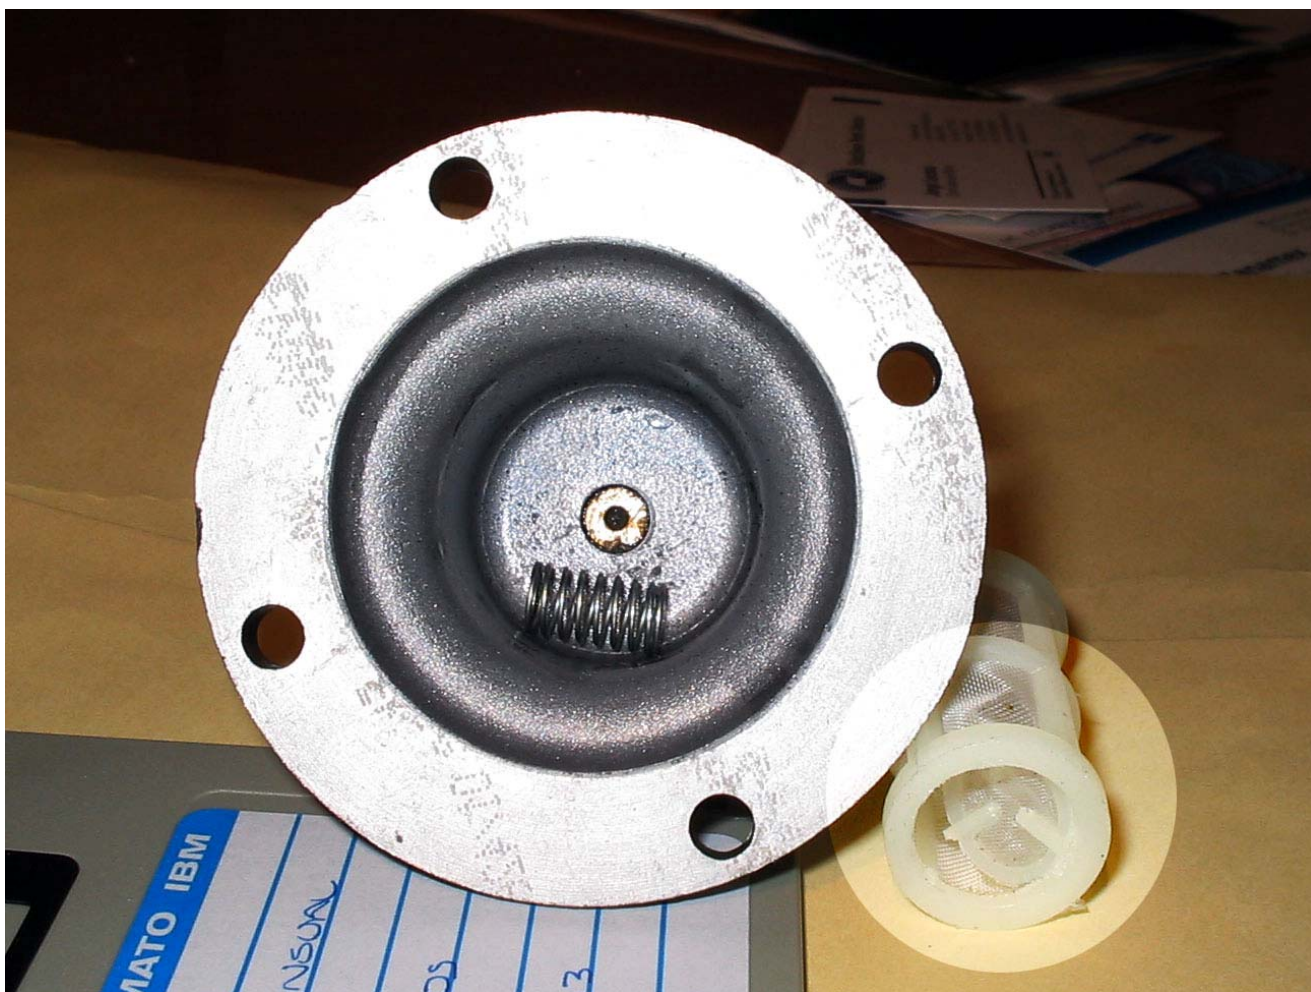
Reported on a Virus 912 aircraft, the retaining spring inside the gascolator damaged the plastic filter. Particles in fuel were therefore not detained by the filter but sucked into the carburetors - consequently the engine RPM dropped.

A mistake in production caused that an incorrect type of gascolator's retaining spring was mounted. Spring's diameter was not large enough to cover the outer-bottom wall of the filter – therefore the spring, being too narrow, penetrated through the base of the plastic filter.

Picture shows the damaged plastic filter base (highlighted area) and spring. Note the base of the filter has been completely penetrated by the too narrow retaining spring.

Check if the gascolator on your aircraft contains the correct retaining spring type. You will find the retaining spring **INSIDE** the gascolator. The spring **MUST BE** of approximately 15 mm diameter to cover the outer-bottom wall of the plastic filter. If the spring is narrower, the spring must carry a washer pressed against the filter base.

If the spring inside your gascolator has a diameter of less than 15 mm and does not have a washer on top, the retaining spring **MUST BE** replaced.

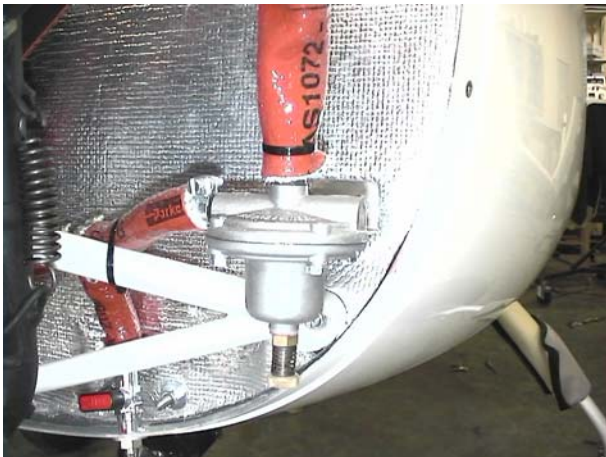
Only the 50 ccm version of the gascolator is potentially affected by this problem. Aircraft equipped with the 50 ccm version of gascolator are Sinus and Virus from SN. 86 to SN. 111. It is also possible that a previously manufactured aircraft carries the 50 ccm version of gascolators if it was serviced and the older gascolator was replaced with the 50 ccm version.

50 ccm version gascolator as mounted on aircraft (**affected**)

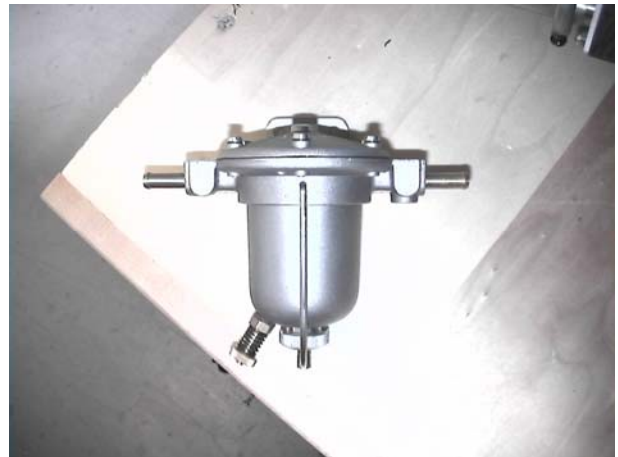
The bigger gascolator, 110 ccm version IS NOT affected by the spring problem.

110 ccm version of gascolator (**not affected**)
