CIRCULAR LETTER No. 22
SERVICE BULLETIN No. 05
to all distributors

**Checking and/or replacing flaps handle
part(s) for Sinus/Virus aircraft family**

Aircraft affected: SN.151 to SN.170
except: SN.168 and SN.169

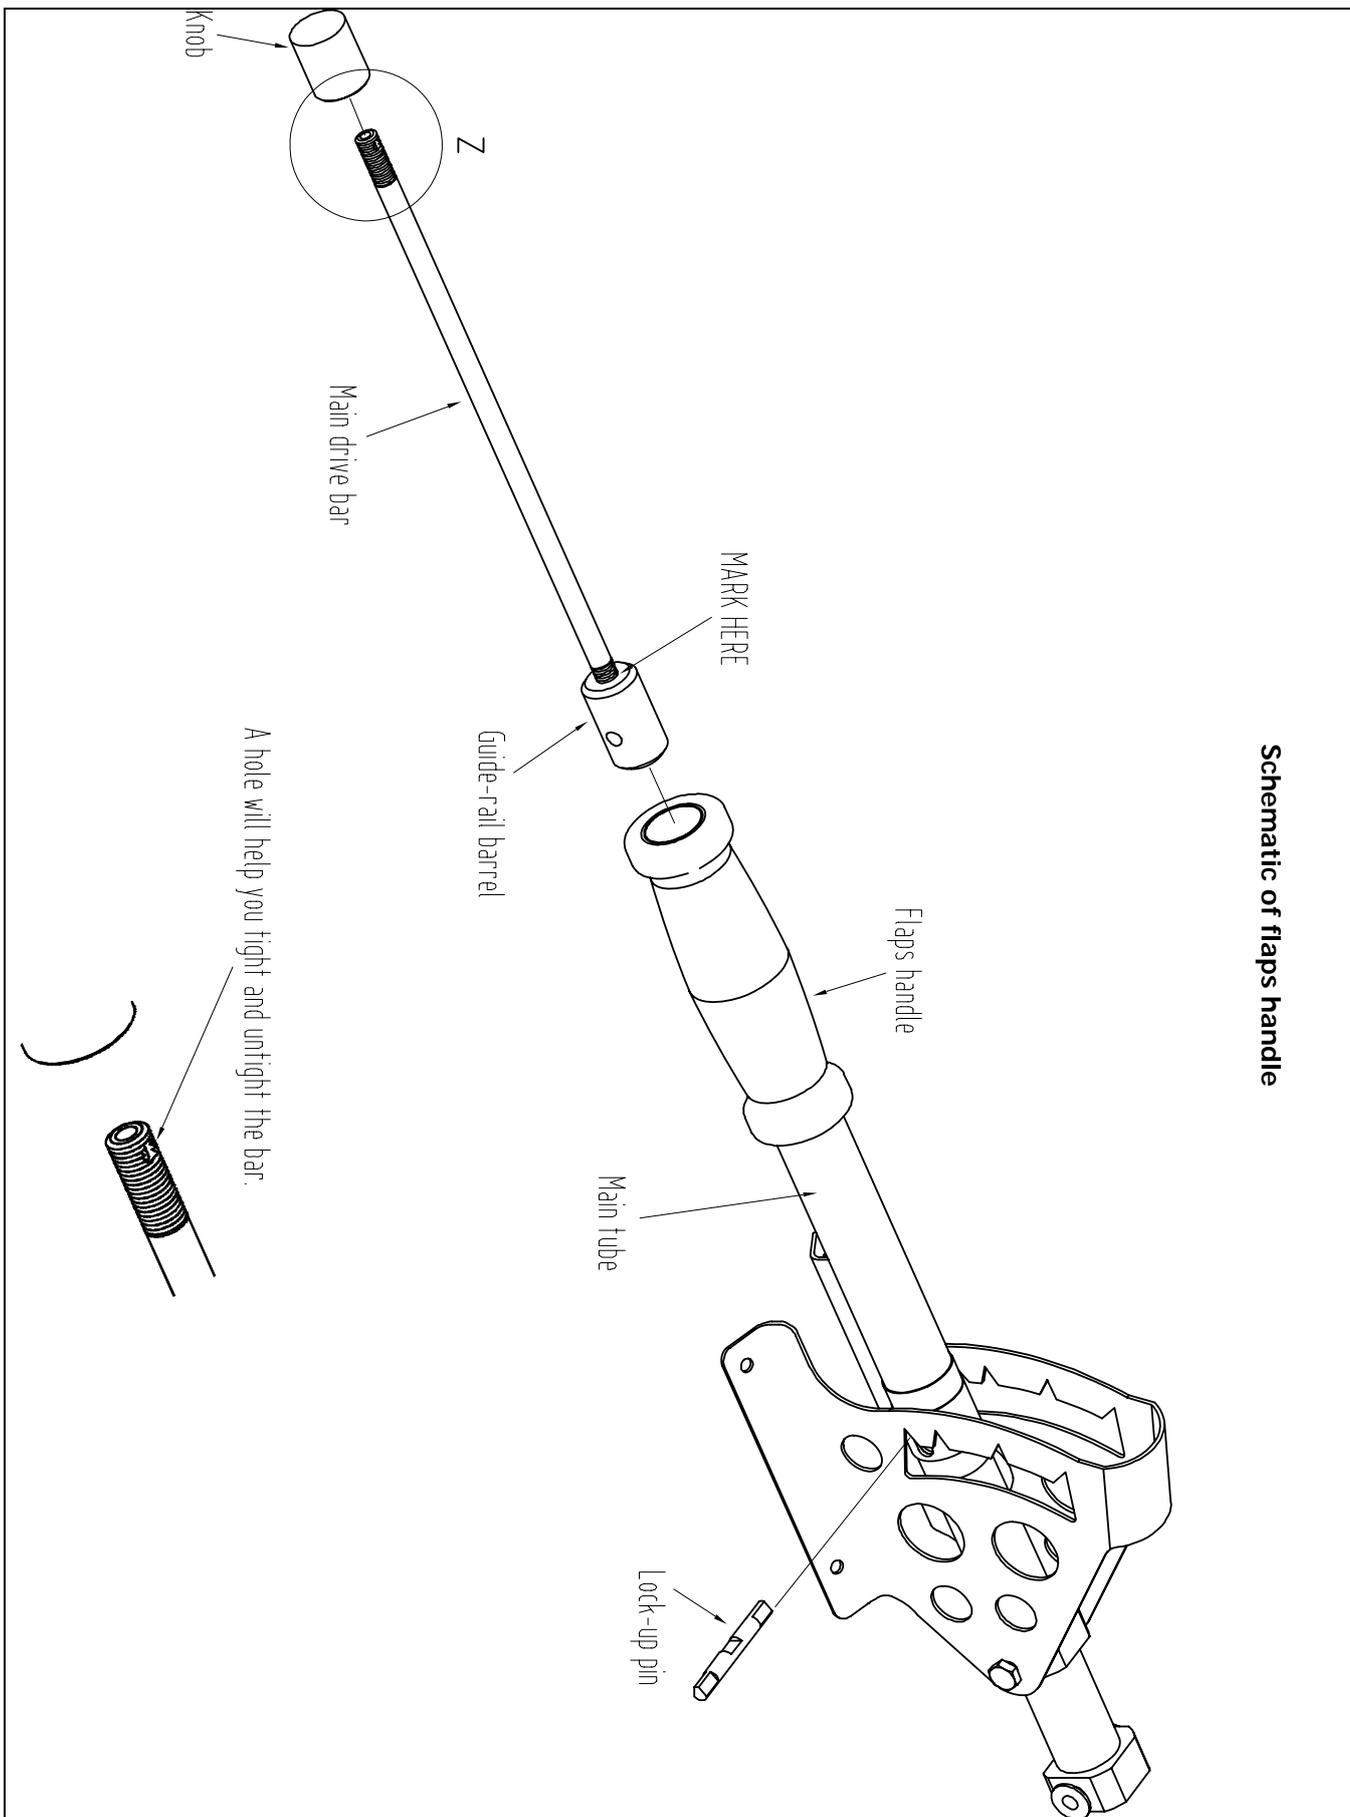
Schematic of flaps handle

Inside the main metal tube of the flaps handle, there is a sliding guide-rail barrel which also holds the lock-up pin. This guide-rail barrel is made of plastic to ensure proper mechanism smoothness.

It appears that during high OATs (Outside Air Temperatures) the main metal tube of the flaps handle shrinks along its inner diameter, thus pressing onto the plastic guide-rail and blocking it completely.

1. Unscrew and remove the casing of the flaps handle.
2. Grab the knob on the flaps handle with your fingers and unscrew it.
3. Unfasten the revealed metal drive bar only so much that it moves out by 8-10 mm (not completely!) - this will release pressure on the lock-up pin.

4. While applying pressure on the metal drive bar, grab the lock-up pin at the base of the handle with a pair of pincers and remove it completely.
5. Grasp the metal drive bar and remove it from the main flaps handle tube completely. Be careful not to lose any parts as there is a spring under pressure behind the metal bar.

6. Now you will see the plastic barrel at the other end of the metal drive bar. First mark the position of the plastic barrel with a marker-pen (this is important for reassembly) and then unscrew and remove the barrel.

7. Replace the barrel with the newly-supplied part and screw it exactly to the position you have marked previously.
8. Re-insert the metal drive bar into the main tube. Note that the holes in the new barrel must be in horizontal position.

9. While applying pressure on the metal bar re-insert the lock-up pin to its previous position. Make sure the pin has been inserted correctly (exactly in the middle of the main tube).

10. Fasten the metal drive bar until you can feel strong resistance (you can use a nail or similar pin which you insert into the hole at the end of the metal drive rod to increase torque).

11. Screw the knob back onto the end of the metal drive rod.

This procedure will take you about 10 minutes. Please take advantage of the schematic on the next page for easier parts' and procedure recognition.
