### **SERVICE BULLETIN No. 12**

## **Deactivation of xenon-type strobe lights**

**Applies to Sinus/Virus/Virus SW/Taurus aircraft which were delivered before March 2011 and are equipped with NAV/Strobe wingtip lights.**

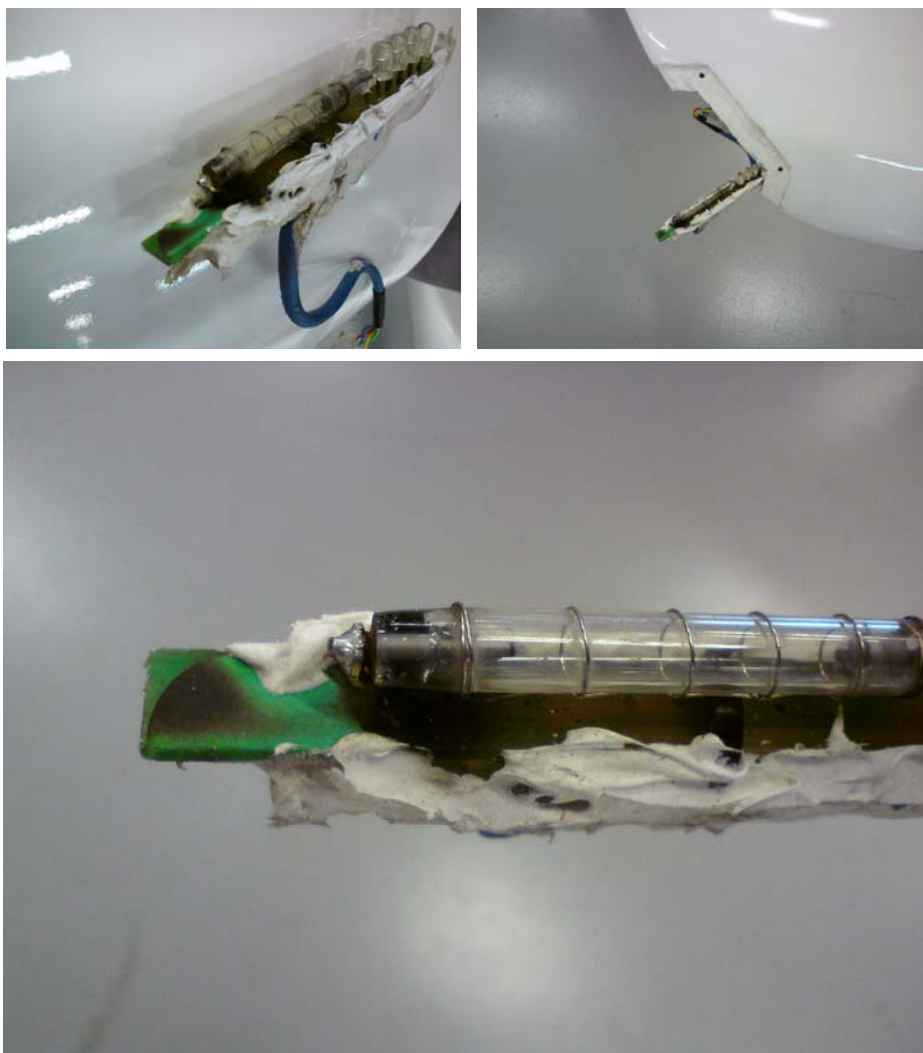
An incident occurred where the sparking from the strobe light ignited fuel fumes in/around the wing just after refueling and caused structural damage to the wing on a Sinus ultralight motorglider upon switching the lights on. The aircraft was still on the ground. The cause of the sparking was determined to be a faulty, aged, xenon-type strobe light. Upon investigation, it was discovered that large, 4 cm long sparks (1.75 inch) sparks were produced by the light unit in question.

**Image 1: Aged, faulty xenon-type strobe light, which caused sparking**

In order to prevent eventual occurrences of sparking with other, similar type xenon-type strobe lights, used in airplanes with serial numbers listed on the cover page, it is required to disable the functioning of the strobe lights. NAV (red, green) lights in the same package are not problematic, as they are made with LED-technology.

Disable and/or remove the switch on the instrument panel, which controls the strobe lights.

Behind the cockpit, locate and remove the central unit of the NAV/Strobe lights. Use the Green and Blue wires from the wing cables to connect the NAV (LED technology) lights directly to the 12 V switch on the instrument panel. This option retains the functionality of the NAV lights and only disables the xenon-type strobes. Required work – 30 minutes, required material – AWG 18 wire approx 2 meters (6 ft), soldering gun or appropriate connectors.

Plug&play replacement packages are ready for shipping at a nominal cost for aircraft out of warranty. For aircraft still under warranty period, the replacements packages will be provided free of charge.. Instructions on installation are provided as part of the replacement package. The new lights are all-LED based, therefore no sparking can occur.
