Number: SB-121-11-01  
Issued: 28-11-2011

**SUBJECT:** Service Alert – applicability of ASB-912-059UL »Checking of the Crankshaft Journal (Power Take Off Side)«

## CHECKING OF THE CRANKSHAFT JOURNAL (POWER TAKE OFF SIDE) FOR ROTAX® ENGINE TYPE 912 AND 914 (SERIES)

ASB-912-059UL

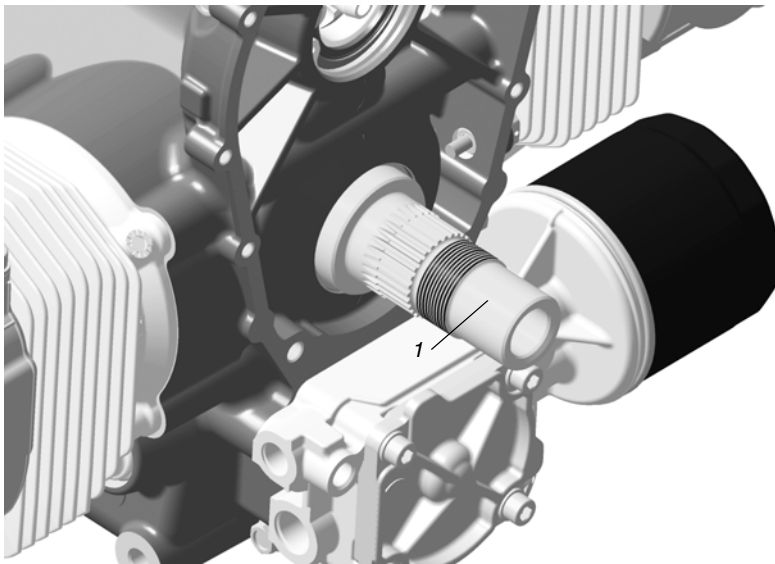
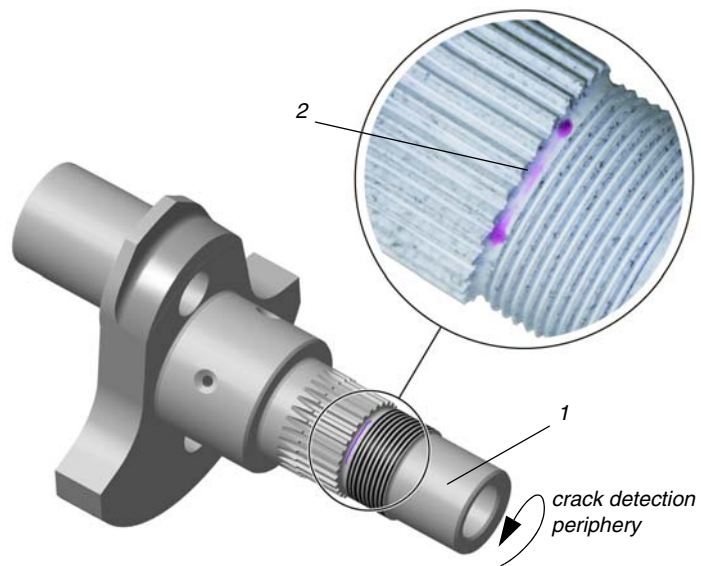
**Fig. 1**  
**crankshaft journal**

Due to a deviation in the manufacturing process some crankshafts may have a crack formation occur on the power take off side. These cracks can cause a breakage of the crankshaft support bearing and may lead to engine stoppage.

- Detailed crack detection in the area (2) of the thread runout using penetration test. Perform this test in accordance to the requirements of the applicable aviation authority in your region for non destructive testing (NDT) and according to DIN EN 571 or equivalent.

- 1 crankshaft
- 2 detailed crack detection

- ◆ NOTE: Protect the crankcase against contamination by the test material.
    - CAUTION: In case of crack or doubt contact your aircraft manufacturer and your nearest authorized ROTAX aircraft engine distributor. The engine must not be taken into operation until the cause has been identified and eliminated.
