Introduction of a new maintenance task

- Category:** INFORMATION ONLY
- Subject:** Inspection of elevator bell-crank attachment bolts
- Affected Aircraft s/n.:** Alpha Trainer: all.
Sinus, Virus, Virus SW: all
- Time of Compliance:** At next 100 hr service interval
- Reason:** Inspection for atmospheric corrosion
- Actions:** Inspection
- Documents:** Future releases of POH, AOI, MM.
- Required Material:** N/A
- Mass and Balance:** Not Affected
- Required Records:** N/A

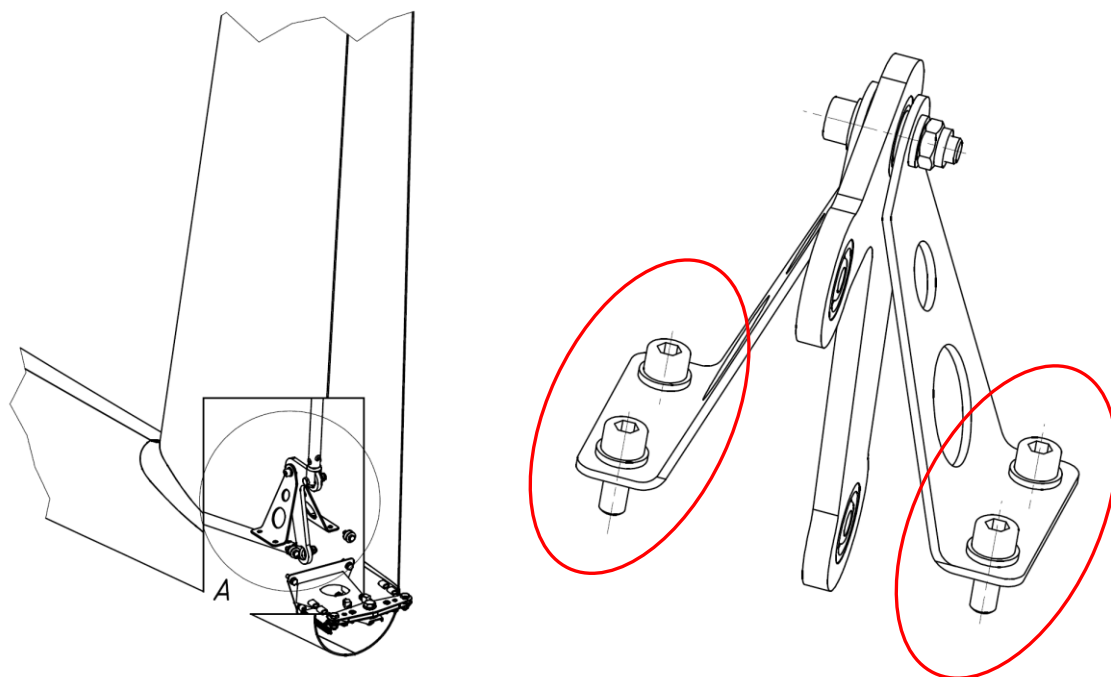
It was noticed in the field that certain older aircraft exposed to a saline environment and/or those predominantly parked outside started showing evidence of surface corrosion on the bell-crank attachment bolts. An inspection is therefore put in place as part of the 500 hr inspection.

At next 100 hr service interval Inspect elevator bell-crank attachment bolts for corrosion and replace on condition with PN 5010655. To access the bell-crank it is necessary to remove the rudder. Make sure the rudder is reintroduced and secured properly after the inspection.

Thereafter, carry out inspection every 500 hrs.
