SB-T-05

SERVICE BULLETIN No. 05

Change of Drivetrain belt check period

Service Letter T-01-2009

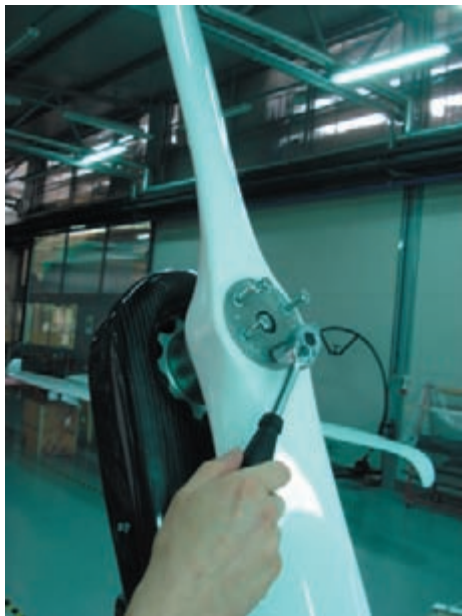
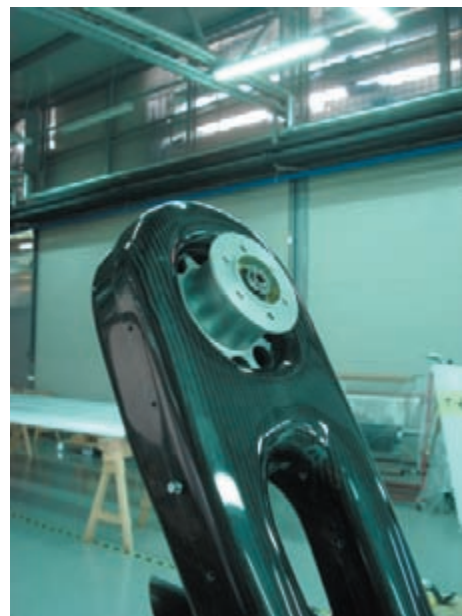
The first thing you need to do when inspecting the drivetrain belt for wear is get access to it. Therefore begin by cutting the safety wires, unscrewing the propeller's fixation bolts and removing the propeller.

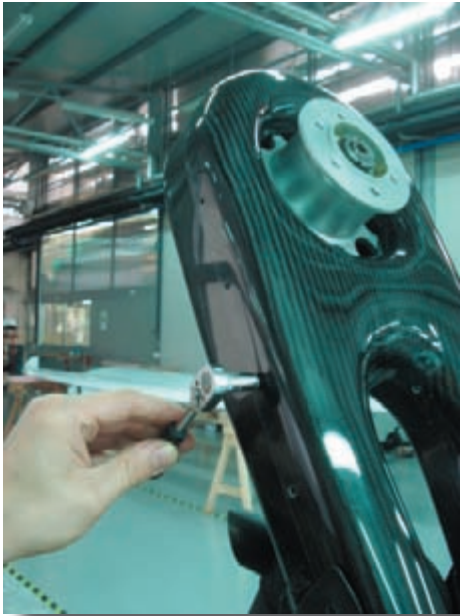
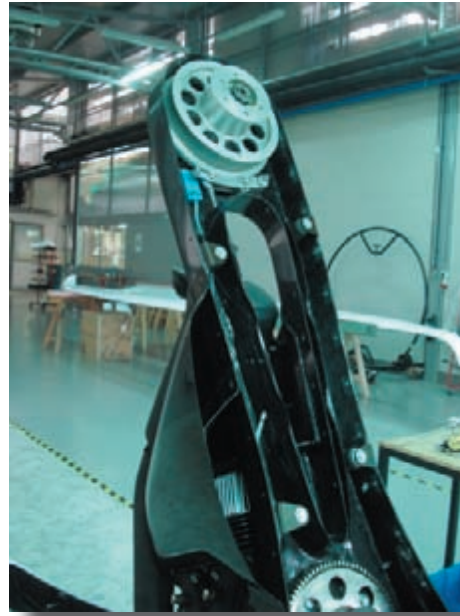
- Continue by removing all of the screws that line the propulsion system's housing and removing the front cover.

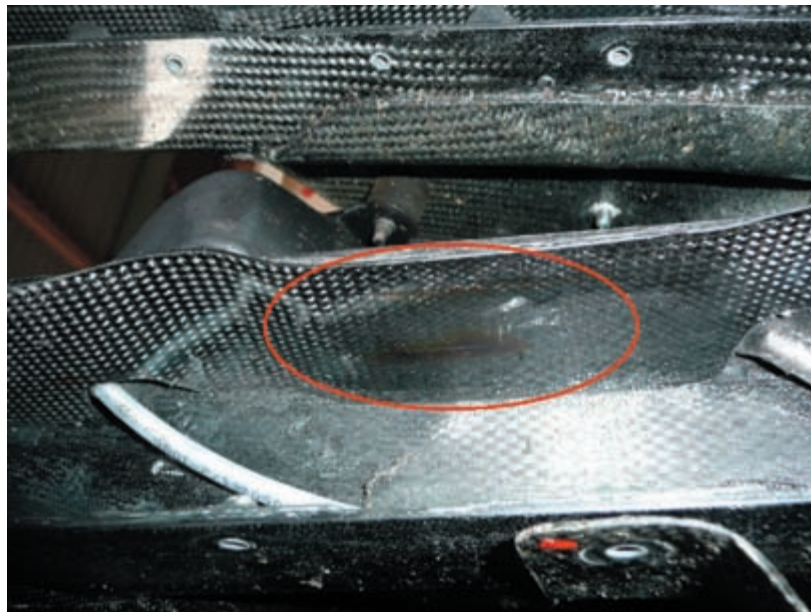
1. Marks of the drivetrain belt rubbing against the propulsion systems housing.

If you found any of the signs of drivetrain belt wear mentioned above or anything else which seems abnormal, please contact leon.b@pipistrel.si and he will assist you further.

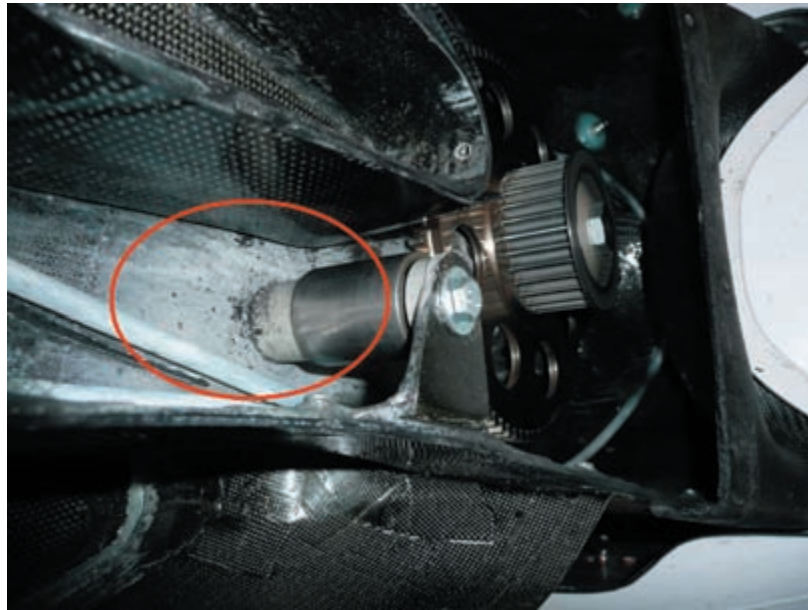
2. An increase in the amount of rubber filings or particles in the housing near the belt roller guides
