INFO SERVICE BULLETIN No. 08

Information regarding replacements of Wheel Brake Assembly

Applies to all Sinus/Virus aircraft up to SN 240.

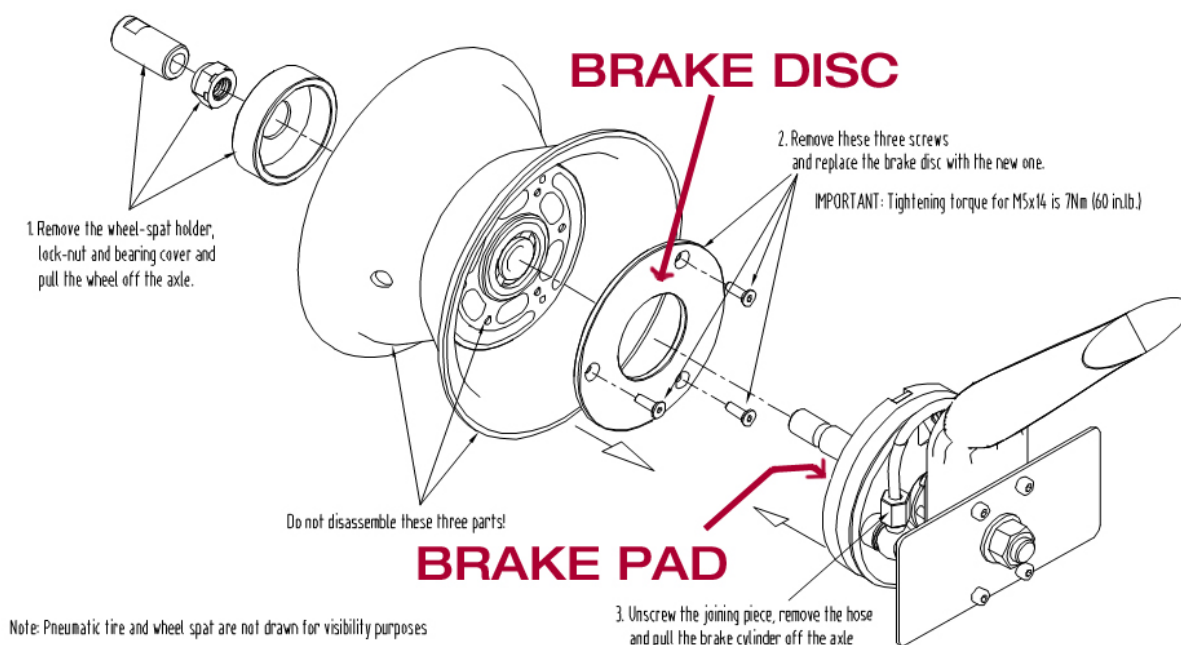
Upon replacement of Wheel Brake Assembly, it is necessary to replace both brake pads and brake discs. The reason for this is that new brake pads are not compatible with old brake discs and vice versa. When ordering individual parts from Pipistrel d.o.o. Ajdovscina, make sure you order according to the below part numbers of the individual components of the wheel brake assembly. This is to ensure problem-free operation.

7267 Wheel brake disc

7274 Wheel brake pad

WARNING! Should the incorrect combination of brake discs and pads be used, braking action may be deteriorated greatly.
